## **CHANGES IN OXIDATION STATE OF CHROMIUM DURING LDEF EXPOSURE**

**Johnny L. Golden**

**Boeing Defense & Space Group**

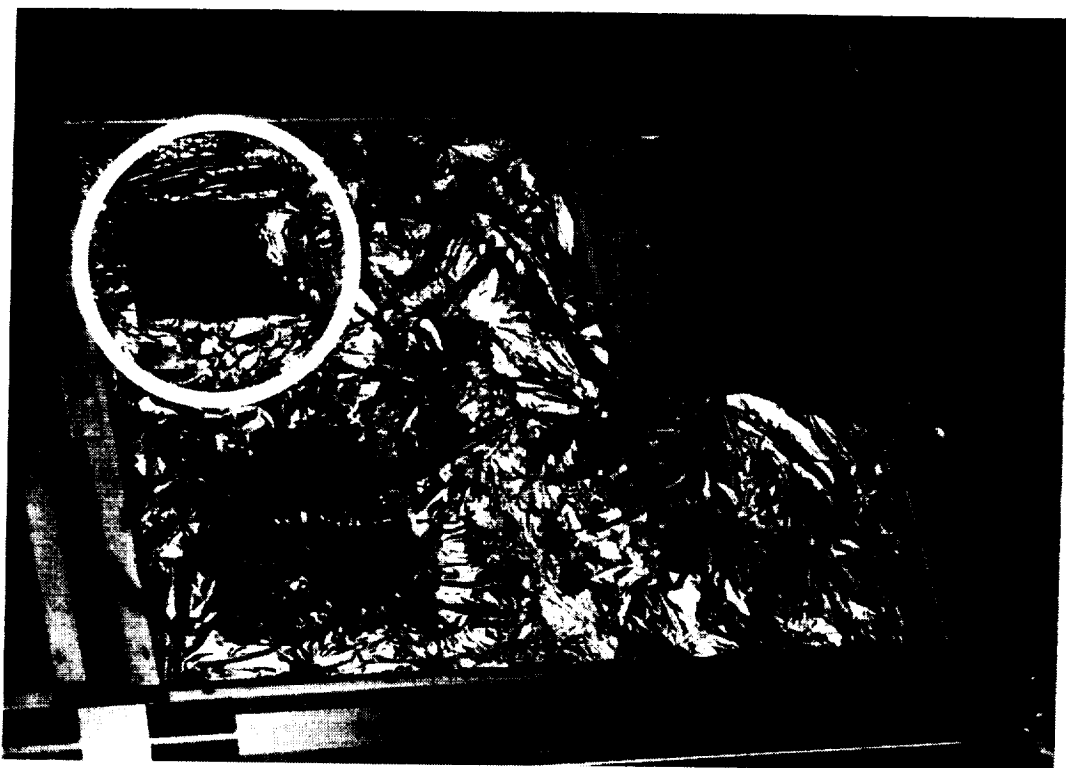
Figure 1. On-Orbit Photograph of Experiment A0076.

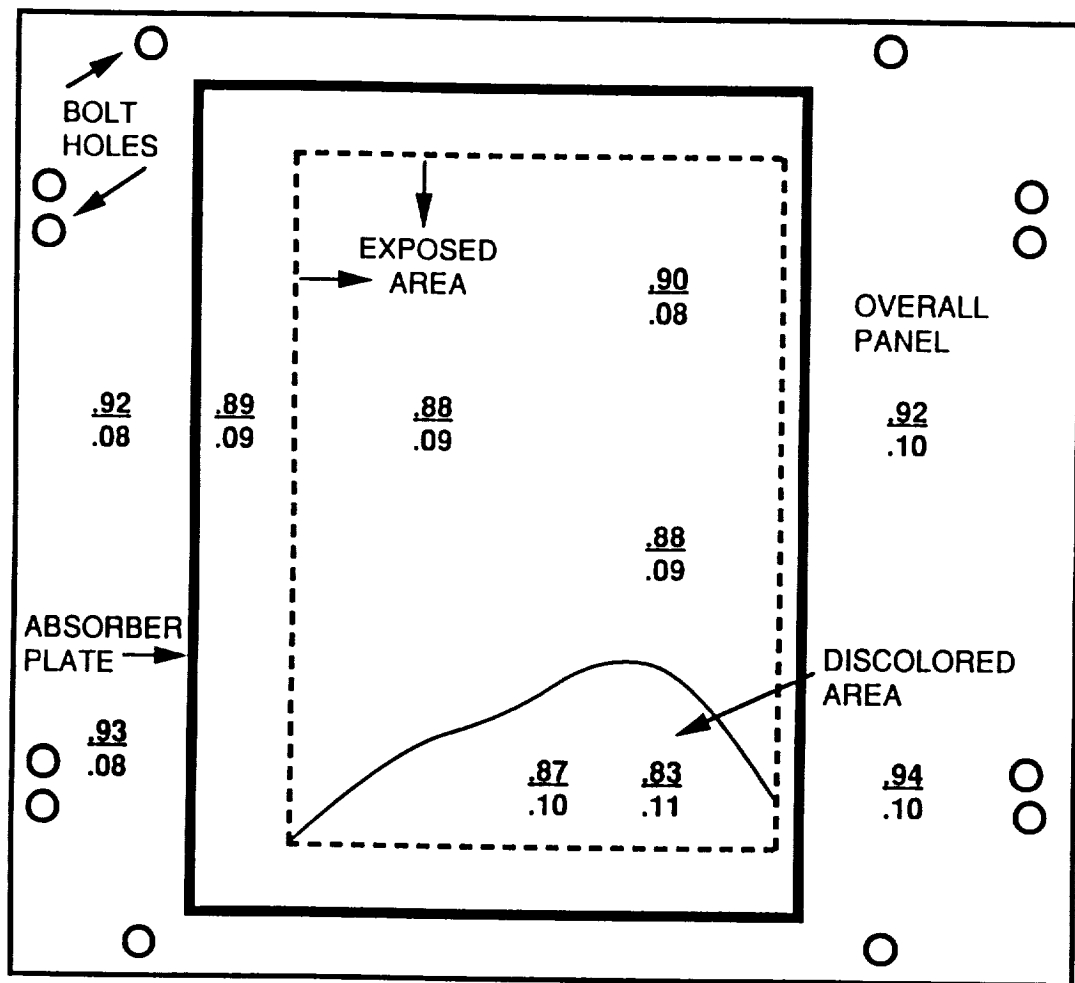
Figure 4.

Optical properties of the black chromium surface were measured and results are shown in figures 3 and 4. Measurements made at unexposed areas of the absorber panel indicate that these areas still meet or exceed the coating specification performance criteria ( $\alpha > 0.90$ ,  $\epsilon < 0.10$ ). Surfaces exposed to atomic oxygen and UV radiation for the full LDEF mission now have a blue tint. The optical properties of the blue area were minimally affected with a slight reduction in absorptance and no change in emittance. However, the surface which was covered with the aluminum flap for an unknown portion of the mission had degraded significantly in absorptance and slightly in emittance, resulting in a tan-color appearance.

Readings are absorbance  
emittance

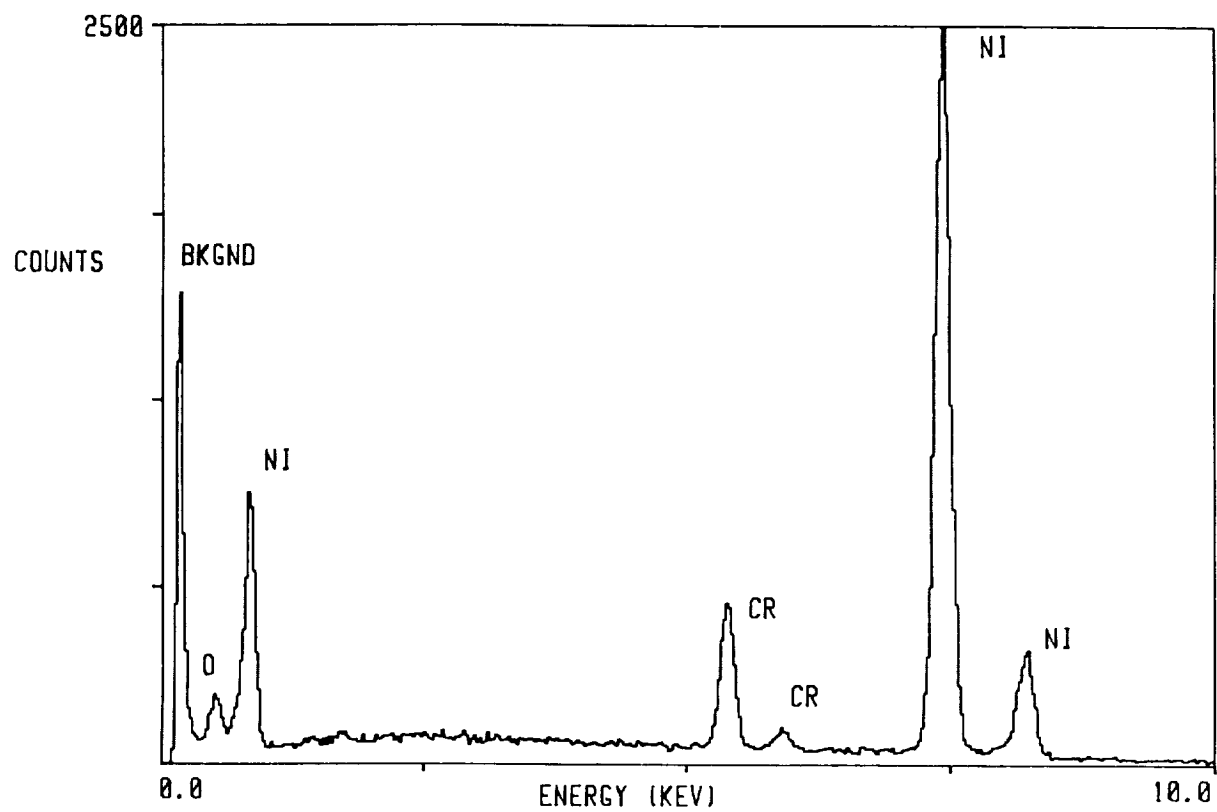
EDX was performed, an example of which is shown in figure 6. The penetration depth of the EDX analysis permits detection of the nickel underplate through the thin chromium layer. No discernable differences between nominal and discolored areas were detected.

Figure 6. EDX of Discolored Area on Solar Collector Panel.

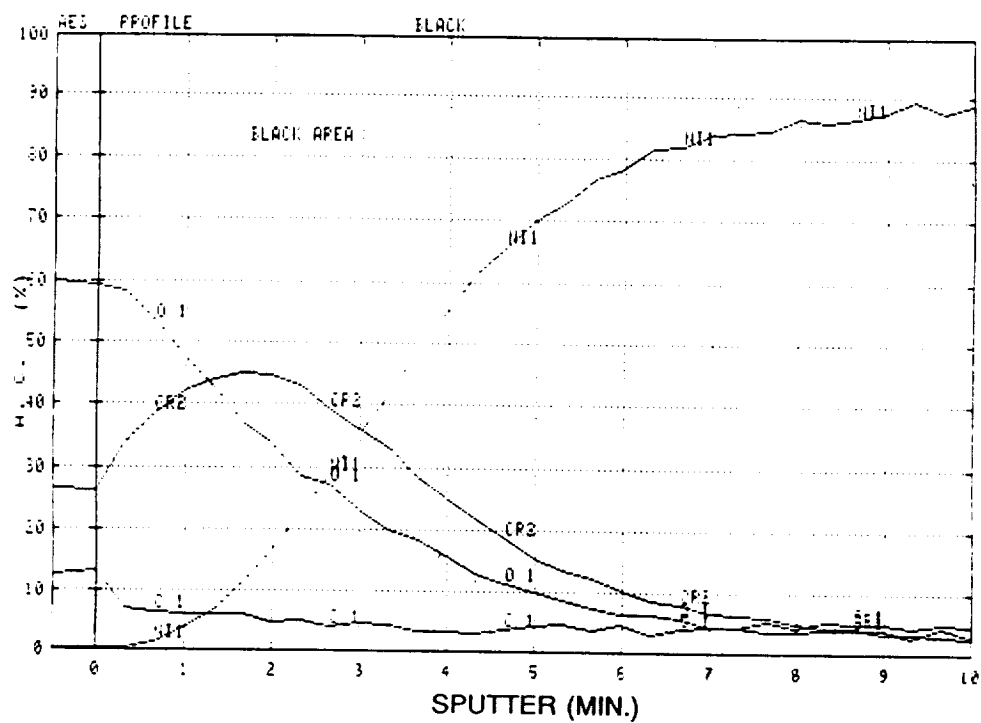
Auger emission spectroscopy profiles were made of the three different areas; these are shown in figures 8, 9, and 10. Differences between the spectra are slight, and the elemental profiles are broad, making interpretation difficult. It appears that the chromium layer has thickened and the oxygen to chromium ratio has increased for the discolored (tan) area, as one compares spectra to those for the blue and then black areas.

Figure 8. Auger Emission Spectroscopy Profile of Unexposed (Black) Area.

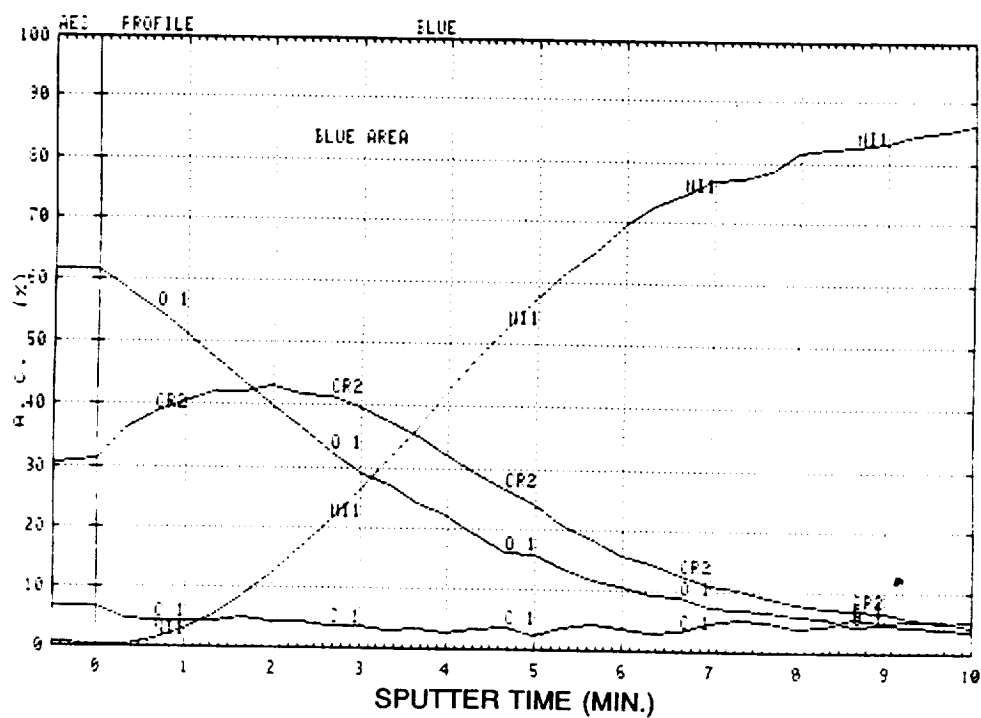
Figure 9. Auger Emission Spectroscopy Profile of Exposed (Blue) Area.

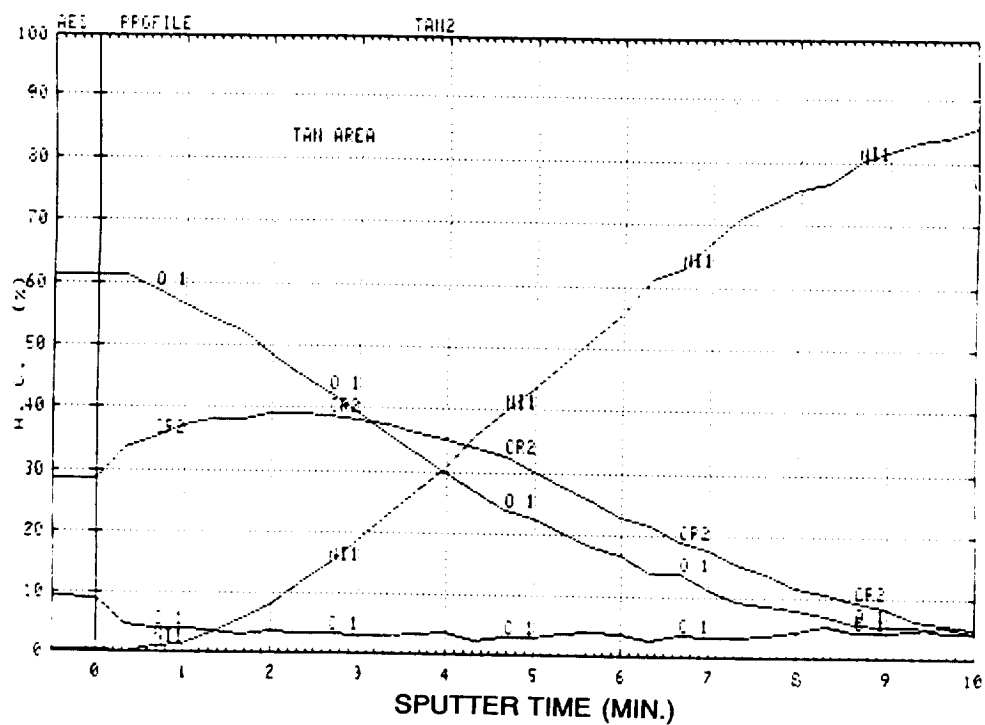
Figure 10. Auger Emission Spectroscopy Profile of Exposed & Discolored (Tan) Area.

These results are not conclusive. But based on the Auger results the following hypothesis is proposed. The discoloration was induced by a thermal effect, caused by the close proximity of the aluminum foil flap to the black chromium coating. The aluminum foil flap, with a low thermal mass and high absorptance to emittance ratio, became very hot, accelerating the atomic oxygen driven oxidation of the chromium. This hypothesis is currently in test using ESCA profiling to determine the chromium oxidation states as a function of depth (fig. 11).
